2023 STUDY REPORTS

Conducted by Element Lab
for Pure Maintenance
(Eagan, MN)

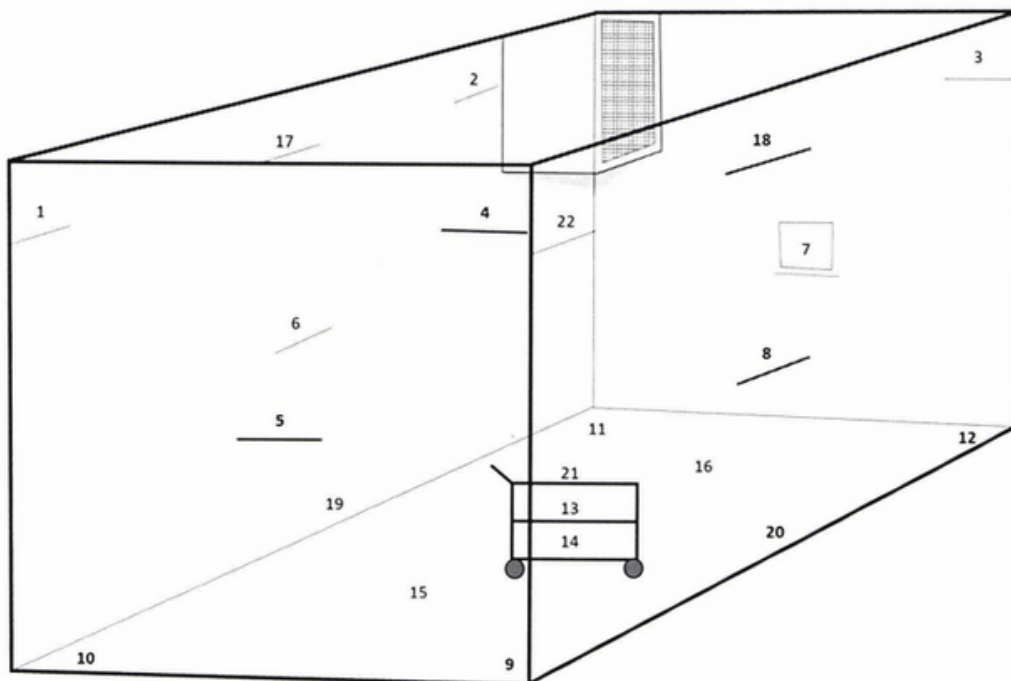
Element Lab expended a large amount of time and resources on creating a test room that was large enough to be able to more closely simulate a real world environment for testing devices such as foggers. The dimensions of the test room and control room are 21.5' x 15' x 12'. This one-of-a-kind test room makes it possible to test against airborne and surface pathogens in a unique and pioneering way.

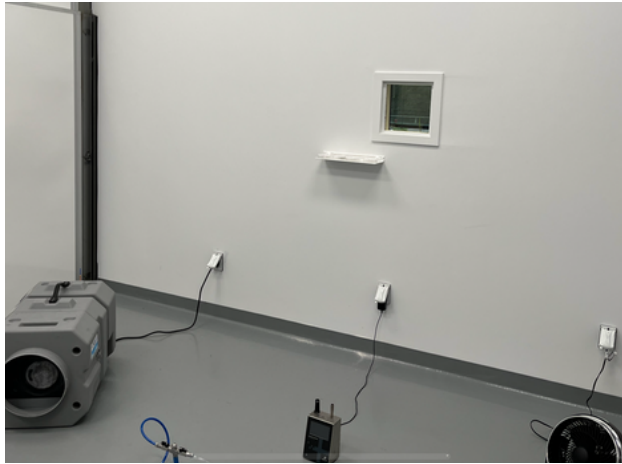
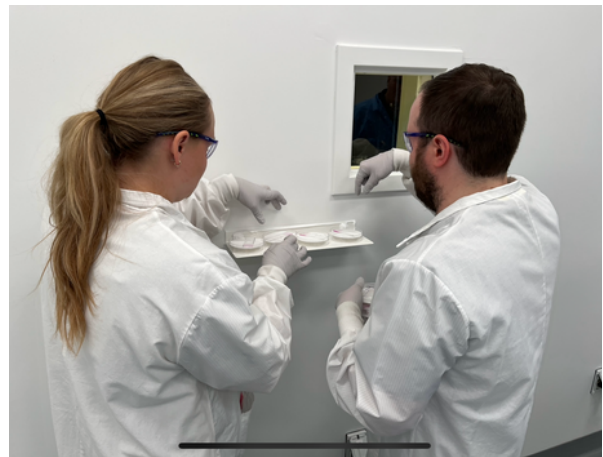
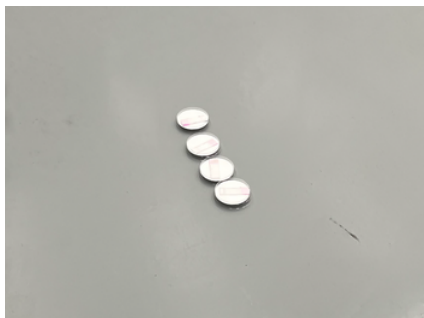
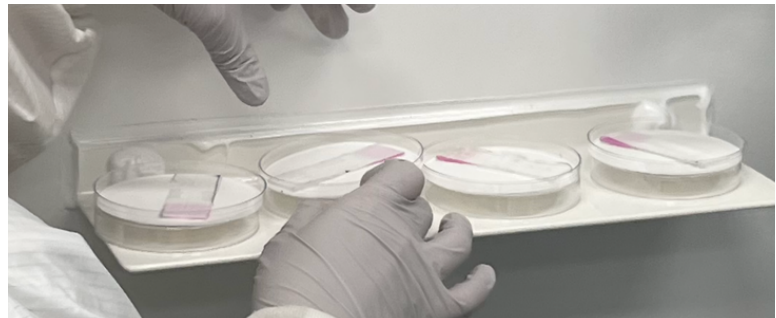
For porous surface testing, Element installed shelves at varying heights and locations throughout the test room in order to determine a fumigant's ability to kill microorganisms high and low, and everywhere between. In total, there were 22 locations on which open petri dishes with cotton fabric carriers were placed. These cotton carriers were inoculated with various bacteria and mold. In order to get a kill on porous materials such as cotton, the fumigant must be able to penetrate into fibers of the substrate, making it considerably more difficult.

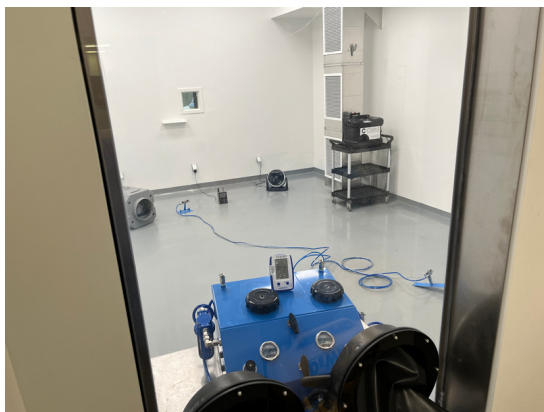
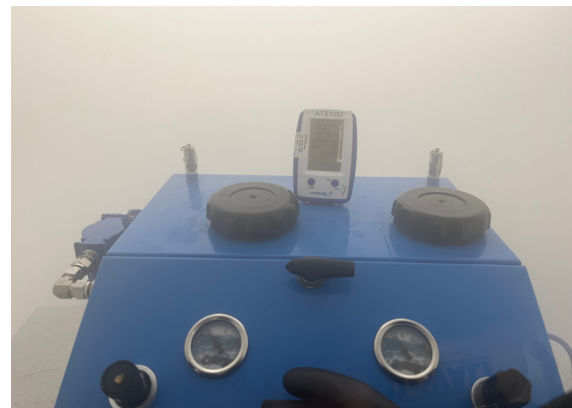
Once the carriers were placed, Pure Maintenance's fogging technology was then turned on and allowed to fog for 8 minutes and 50 seconds, at which time, the machine was turned off.

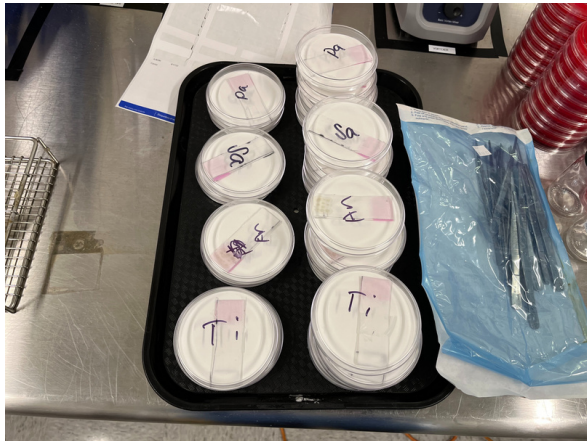
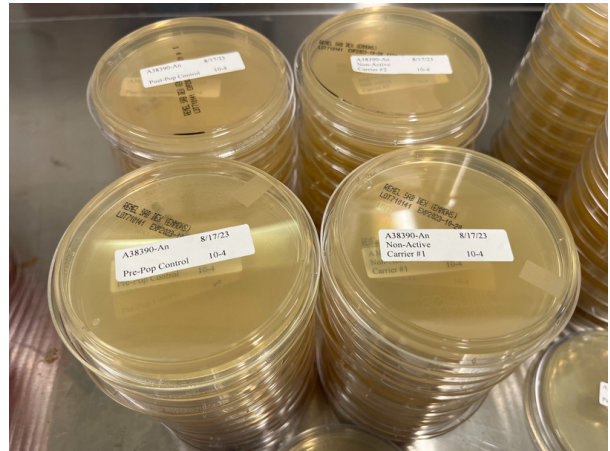
Pure Maintenance's fogging technology was then turned on and allowed to fog for 8 minutes and 50 seconds, at which time, the machine was turned off. After the Pure Maintenance dry fog machine was turned off, the room exhaust system was engaged in order to flush out the peracetic acid from the room. After airing out the room, the microorganisms were removed from the carriers and were transferred to vessels containing neutralizing subculture medium. The subcultures were incubated and assayed for survivors.

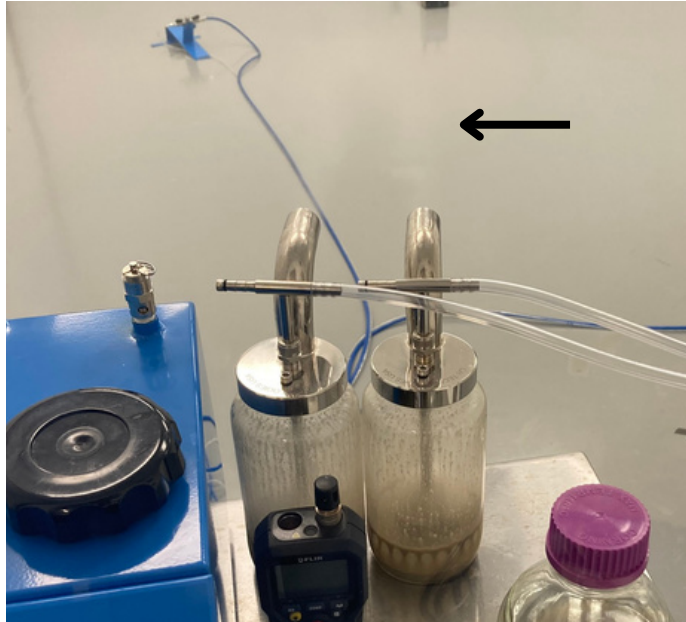
For the bioaerosol testing, the same large room was used. In order to disperse spores into the air of the test room, several million spores were nebulized into the air while the internal ceiling fan was running. This assisted in keeping the spores aloft during treatment and testing.

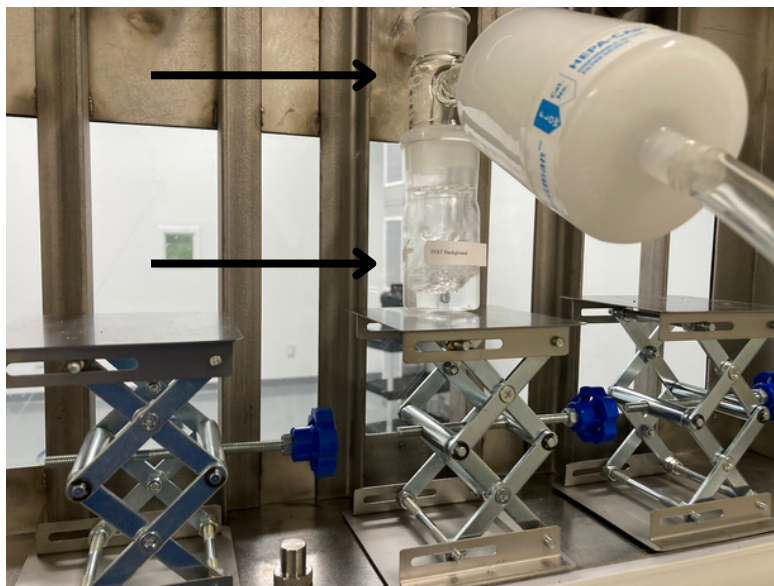
Again, the Pure Maintenance dry fog technology was turned on and the room fogged for 8 minutes and 50 seconds at which time it was turned off. One minute and 10 seconds later, at the 10-minute mark from the start of the fog, an impactor that was connected to the test room was deployed. The purpose of the impactor was to pull out the microorganisms that were just infused into the room back out of the room into a solution that was then plate for culturing.
